# REPAIR, EVALUATION, MAINTENANCE, AND REHABILITATION RESEARCH PROGRAM

TECHNICAL REPORT REMR-CO-6

## STABILITY OF DOLOS OVERLAYS FOR REHABILITATION OF TRIBAR-ARMORED RUBBLE-MOUND BREAKWATER AND JETTY TRUNKS SUBJECTED TO BREAKING WAVES

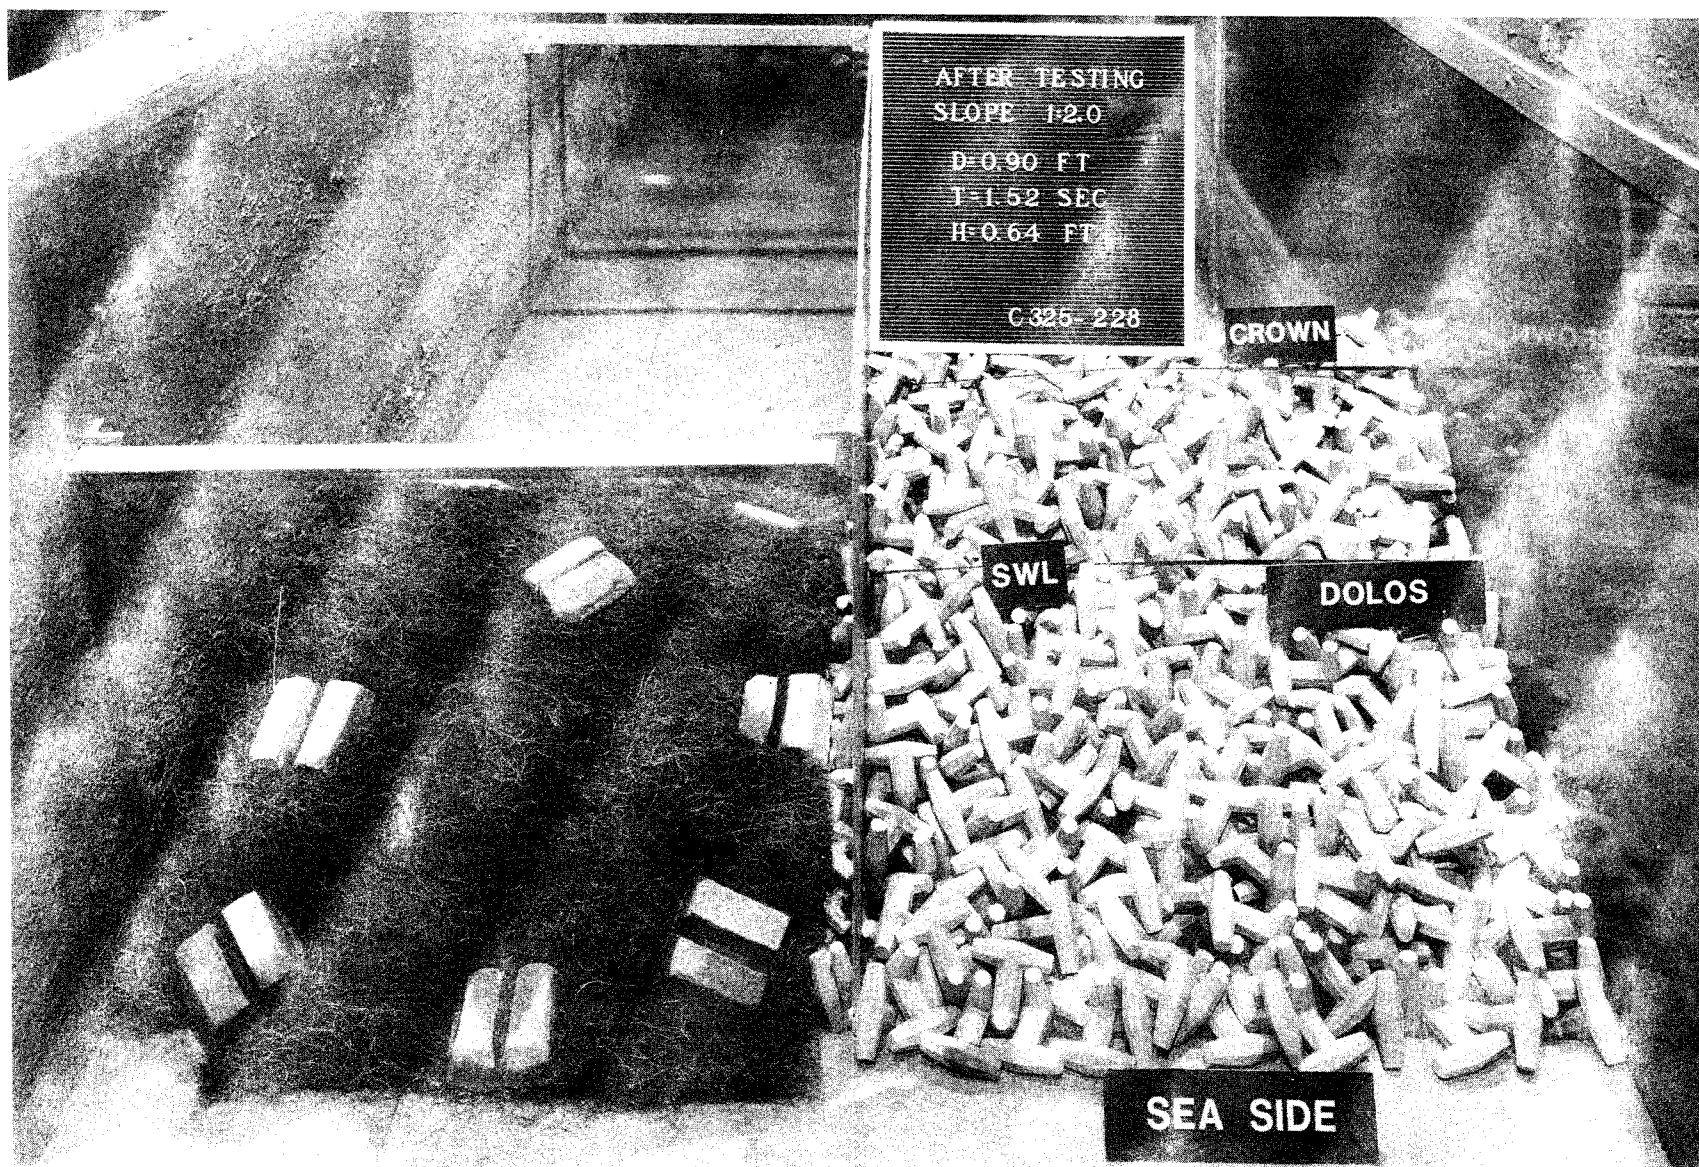
Photo 9. Sea-side view after attack of 1.52-sec, 0.64-ft waves;  $d = 0.90$  ft;  
 $W_a = 0.442$  lb; 1V-on-2H structure slope

Armor units were placed randomly in two layers, and the number of armor units per given surface area was equal to that presently recommended for new construction in EM 1110-2-2904 (Headquarters, Department of the Army 1986). Photos 5-11 show typical after-testing conditions of the structures.
